J/105 Technical Bulletin April 24, 2001

To: J/105 Owners & Dealers

Fr: J Boats & TPI

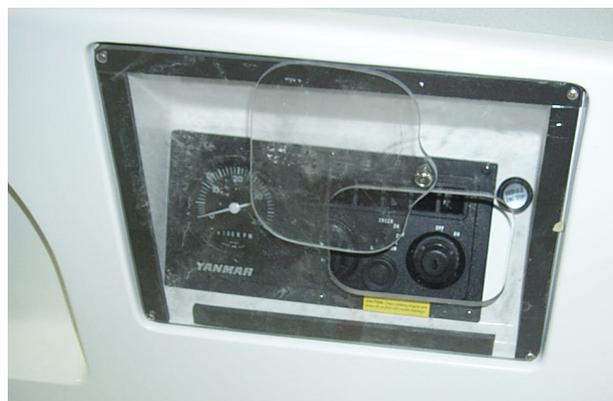
Some owners of wheel equipped J/105s have been reporting having difficulty with their engine stop cables. In particular, they have found them difficult to pull out, especially after some time in salty climate. In most cases, just keeping them lubed will do the trick. Up until now, wheel equipped boats have had the cable run to the port side of the binnacle. Because Yanmar only provides the cable in fixed lengths, TPI has coiled any extra length and wire-tied the cable inside the binnacle. A J/105 class website posting suggested that owners undo some of the wire ties to improve the cable action. However, we know of one instance where an owner, while motoring, turned his boat sharply and the stop cable caught on the clevis pin connecting the steering chain to the cable. **Before sailing again, please be sure to check the run of your stop cable and be sure the cable is clear from any moving parts.**

To help improve the action and to reduce the chance of the above incident, TPI has specified a new location for the stop cable: centerline aft, inside the recess for the engine panel. The cable has a straight shot out of the starboard side of the engine, aft along the upper inboard side of the fore/aft partition (between engine/steering and starboard cockpit locker), wire tied to the starboard cockpit support tube (inside aft lazarette) and looped around to the panel. This is a straight run, and reachable by the Yanmar stop cable fitted on most current J/105s. The change only involves drilling one small hole. Both tiller and wheel boats will now have the same location.
