# Rigging and Maintenance Tips

## J-105 Furler Warning from Harken!!!

**Mike Lee, Harken, March 2001**

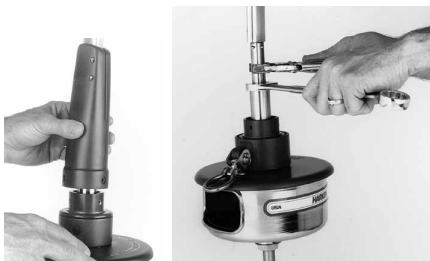
**Symptoms:** The foils will not rotate because they will appear to be stuck. However the real danger is that there is a slim chance of losing the rig.

**Danger:** The forestay is unscrewing from the drum. The problem is that the threaded-stud that is attached to the forestay is backing out of the drum because it wasn't locked down properly. When the stud backs out it is in effect getting longer and therefore it will jam up against the foils preventing them from rotating.

**The Solution:** To lock it properly, there is a piece that is called the locking collar that lives underneath the torque tube. The locking collar needs to be screwed all the way up so that it bottoms out snug on the underside of the rod fitting. This will lock everything tight in place and if it were not done it would have the same effect as leaving the cotter pin out of a turnbuckle.
