# ***In The Wind***

**J / 1 0 5   C l a s s   A s s o c i a t i o n**

**S p r i n g   2 0 1 8   •   V o l u m e   9   •   I s s u e   2**

# Technical Committee Report

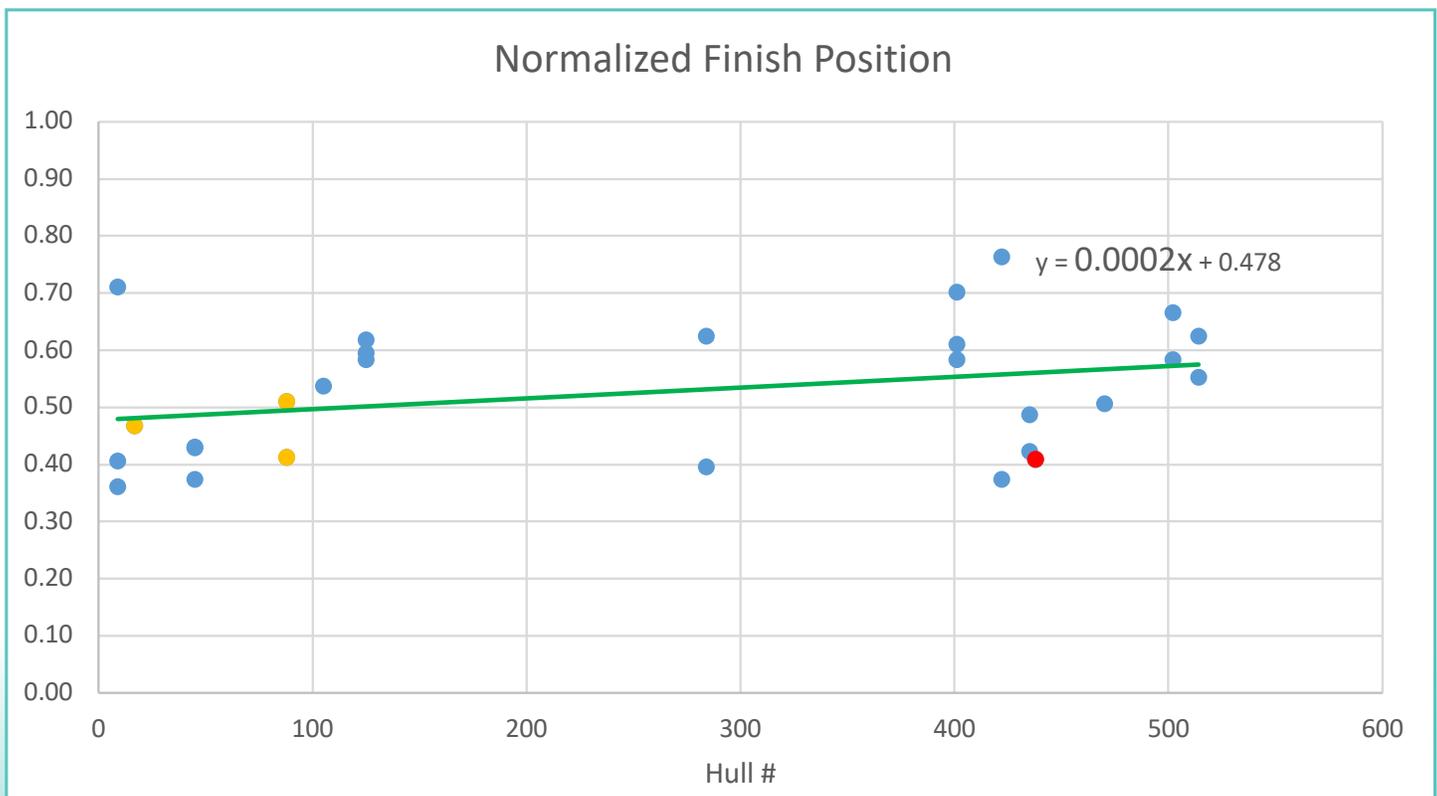
Data for the three most recent Lipton Cups were made available to the Technical Committee. The normalized average finish position for each of the boats in each of the events is shown in the figure below. The green trend line shows the "average" change in finish position as a function of hull #. As can be seen, it trends up slightly, although the slope is quite low.

This plot shows finish position as a function of hull number. It would be better to plot finish position as a function of uncorrected boat weight. However, weight certificates are not available for most of the San Diego boats, making it impossible to create such a plot. The yellow dots represent the two boats with the largest known amount of correctors. 300+ lb. of correctors are in each of these boats. The red dot is the known heaviest boat which was 300+ lb. over Class minimum. As can be seen, the heaviest boat actually performed as well or better than the lightest boats.

The conclusion that can be drawn from this is that there is most likely a performance difference between pre-SCRIMP and SCRIMP boats, especially in rougher conditions, but

that the difference is not as dominant as the anecdotal observations would imply.

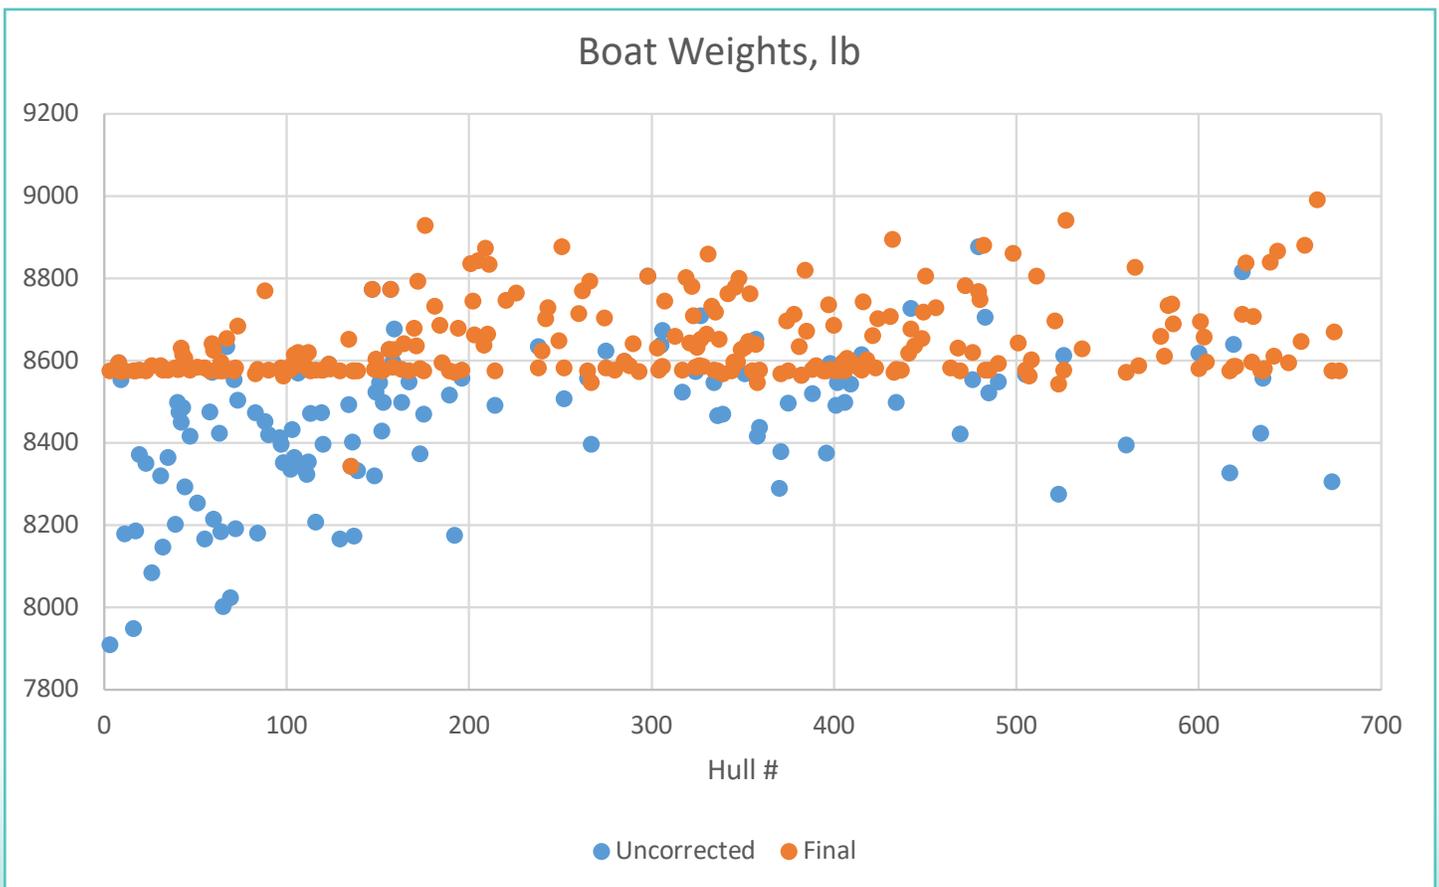
A part weight review by J/Boats in 2008 indicated that the average pre-SCRIMP hull was 280 pounds lighter, and the average pre-SCRIMP deck is 60 pounds lighter than for SCRIMP boats for a total average difference of 340 lbs. Looking at the weight certificates on file with the Class Office, the average uncorrected weight of pre-SCRIMP boats is 8363 lb ( $\pm 176$  lb), while SCRIMP boats average 8644 ( $\pm 134$  lb), a difference of 281 pounds. Plots of the uncorrected and corrected weights, and mass of corrector weights of all these boats are below.

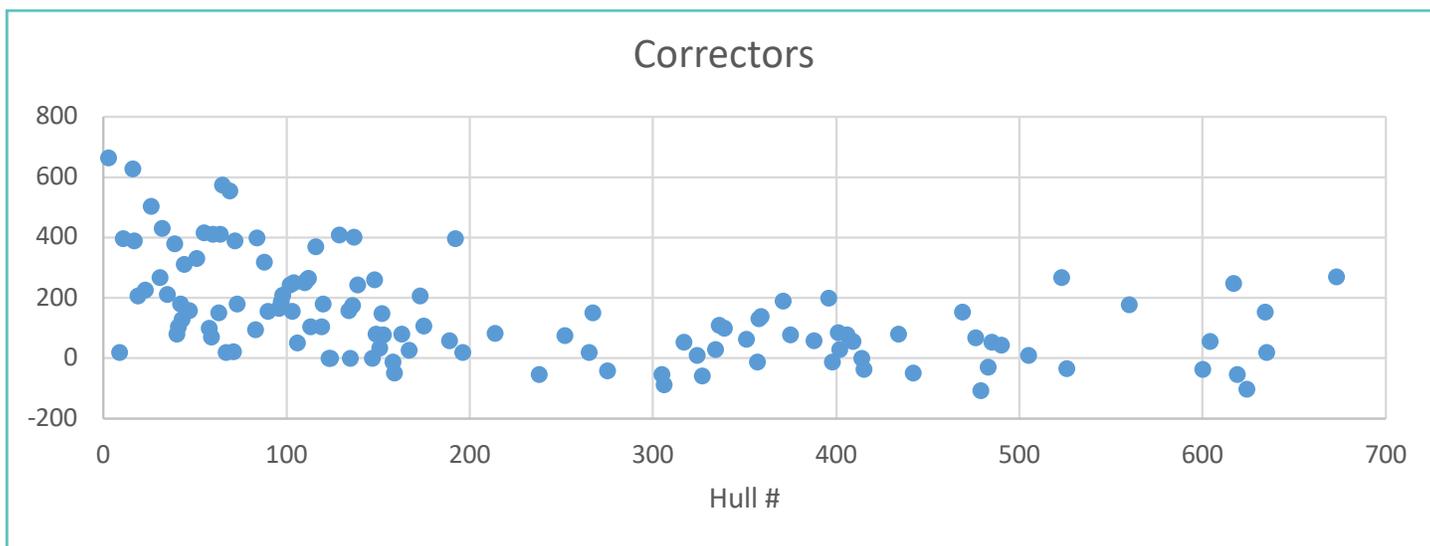
In effect, this quote is stating that the locations presently used for corrector weights beyond the first 400 lbs. are the best locations to position all the corrector weights. However, according to J/Boats, the majority of the hull weight difference, about 180-200 lbs. of the 280 lb. difference, is due to modifications made to the structural grid of the keel floor. This makes an argument that a sizable portion of the weight difference is centered and low in the boat, more or less in the same area as the Class presently allows the first 400 lbs. of correctors to be positioned.
