# Best Practices

By Bruce Stone, Fleet 1

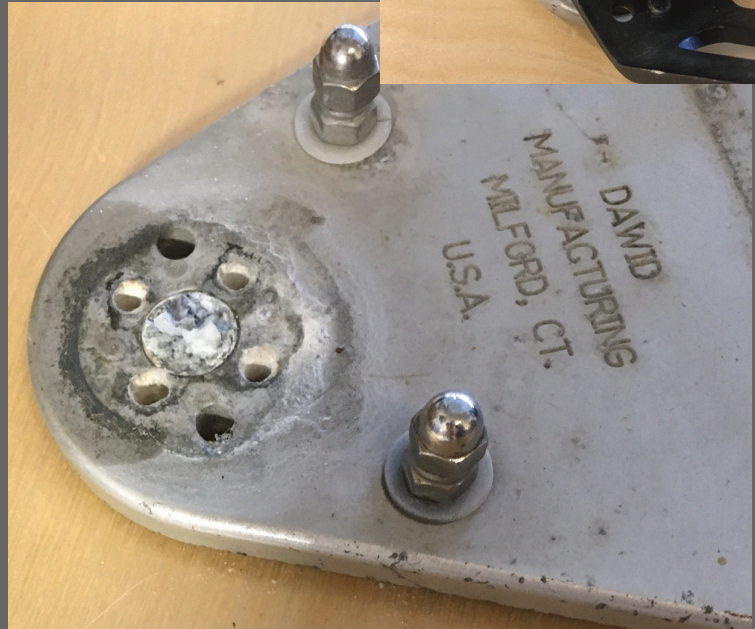
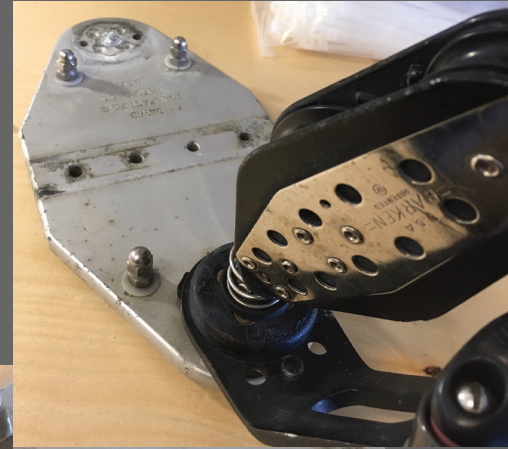
**MAINSHEET:** If you have the Dawid aluminum plate that splits your coarse tune from your fine tune, it is recommended to disassemble and clean your mainsheet system, as this area is prone to corrosion due to stainless fasteners being attached to aluminum. See pitting in the photos. Good time to replace the Harken fittings as they are under a lot of load and wear out.
